H2Oforall and SafeCREW - 'Preparing drinking water supply systems for climate change – case study insights"

An overview of trihalomethane risk in Irish drinking water from peatland dominated catchments

Valerie McCarthy, Dublin City University, Ireland

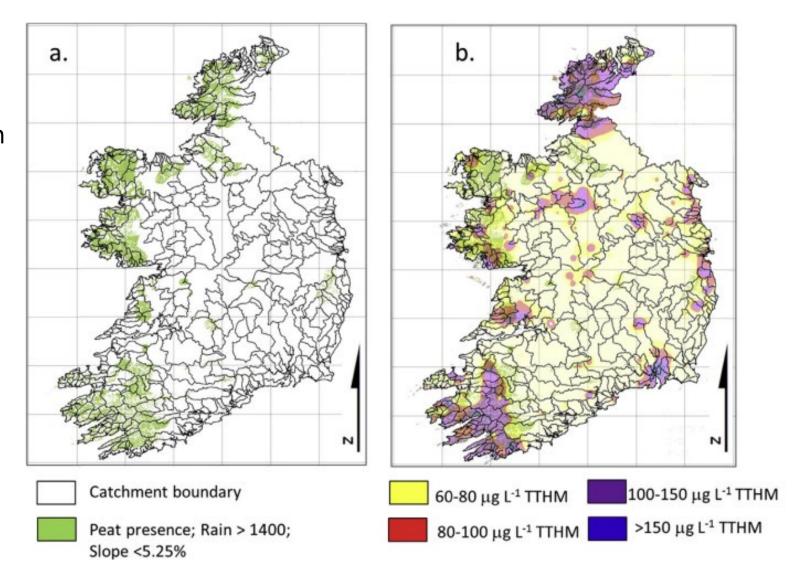
Irish Catchment boundaries showing:

Peat presence, shallow topographical slopes slope <5.25 % and annual rainfall with >1400 mm (higher than average) correspond with highest TTHM concentration.

Higher total trihalomethanes (TTHM) concentrations in drinking water in Ireland have been found to be associated with

- Peat presence,
- Shallow topographical slopes (<5.25 %) and
- Higher than average rainfall.

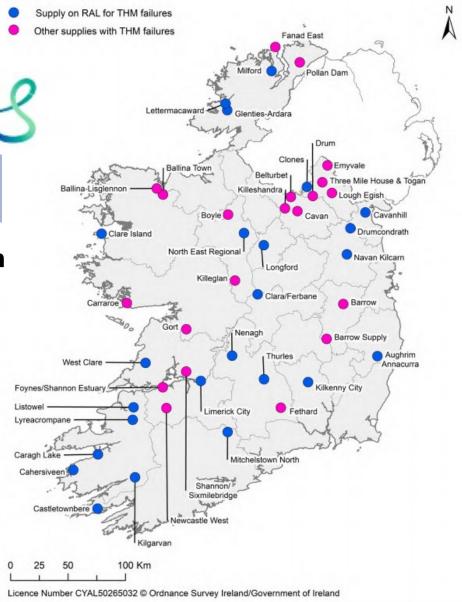
Public supplies on RAL for THM or THM failure during 2023. Source: EPA drinking water quality in public supplies report (2023)

- Based on the 2023 EPA Drinking Water Quality Report 1 in every 20 public supplies in Ireland failed the THM limit.
- With the number of supplies on the on the Remedial Action List (RAL) for THMs impacting almost 300,000 people.
- These figures represents an increase from previous years and not only reflect increased monitoring efforts, but additionally heavier **rainfall events** experienced in the previous four years associated with Climate Change which have increased **levels of organic matter in rivers and**lakes in Ireland.

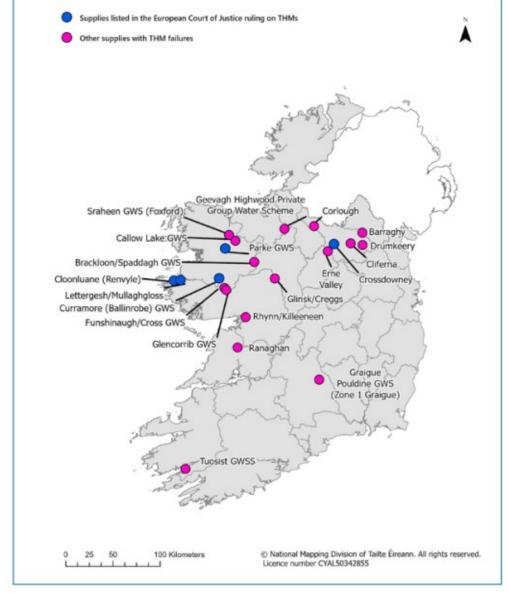
Private group schemes with THM failures in 2023. Source: EPA ISBN: 978-1-80009-189-4 (2023)

2023 - **21** private group schemes supplying 22,000 people failed the standard for THMs. This is an increase on the 2022 figures – Again heavier rainfall associated with this increase.

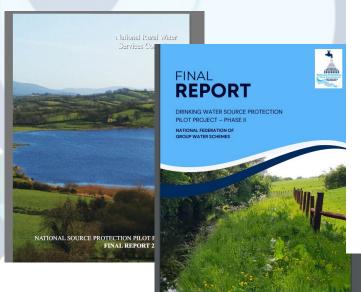
Fencing erected as part of source protection works in Irish Group Water Scheme (from: NFGWS -Source-Protection-Phase-II-Report).

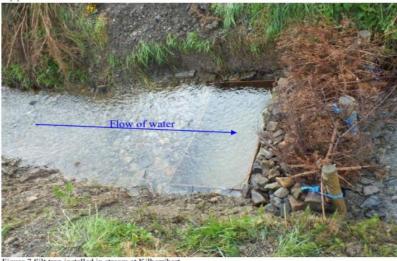
Figure 7 Silt trap installed in stream at Kilberrihert

Sediment trap in a small watercourse constructed to protect the Freshwater Pearl Mussel in the River Allow. (Image: Fran Igoe)

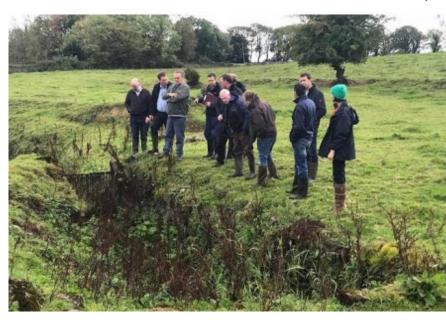
A low earthen bund or bank reducing or preventing overland flow entering the watercourse (NFGWS, 2020)

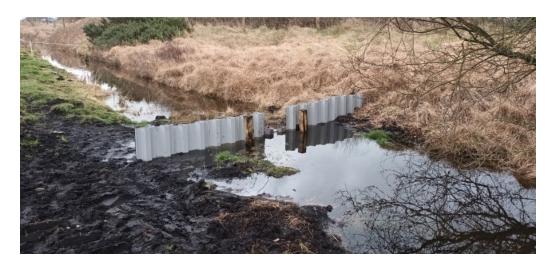
Drain on a farm in Ireland with plastic dam was installed – re-wetting agricultural peat land. (Source: FarmPEAT)

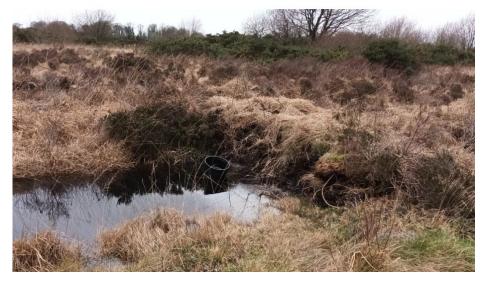
A pipe through a peat dam was installed to give flexibility to the farmer if they wished to adjust the water levels within the drain on a farm in Co. Roscommon. (Source: FarmPEAT)
